Manhole Inspection Summary

Manhole # S11C1_001MH

Record Plat: **11C1** Node: **001** Status: **Found**

Location Address: **S. Edgewood**

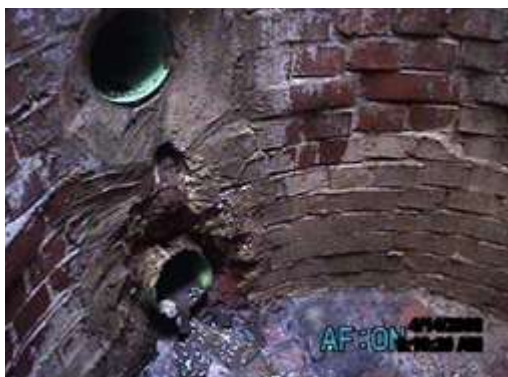
Defect 5

Drop extension seal looks thin

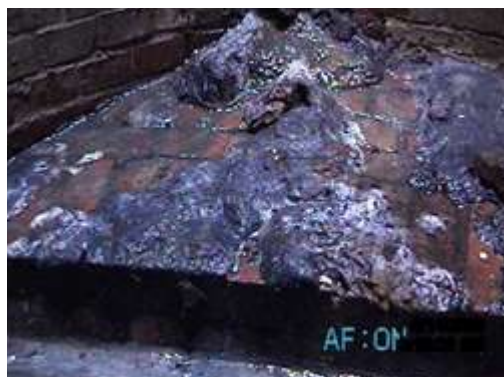
Defect 6

☒ **Debris**

Debris on bench

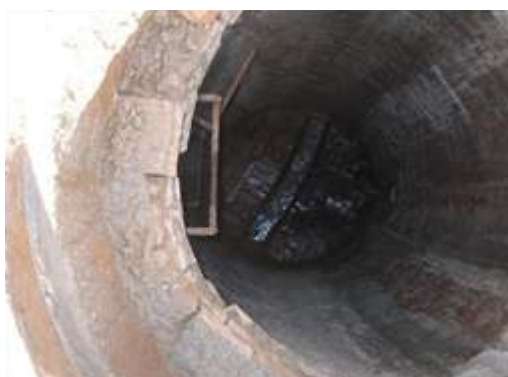
Defect 2

Offset: **4** (in.)

frame offset 4"

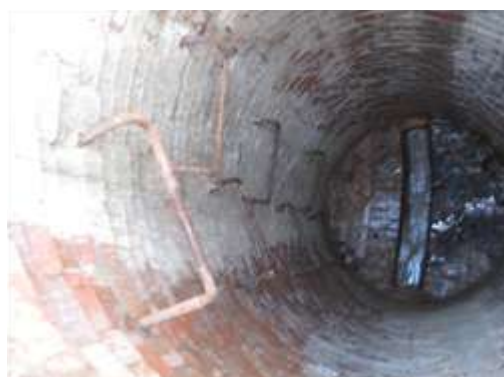
Defect 3

☒ **Corroded**

Corroded steps

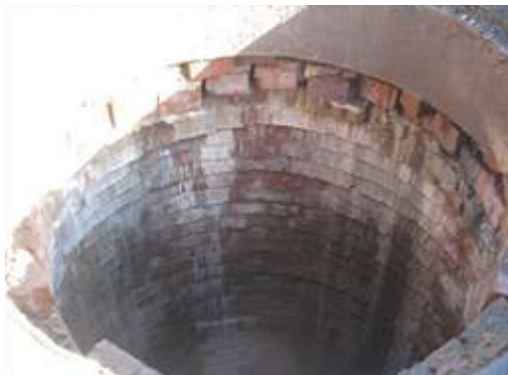
Defect 1

infiltration from top

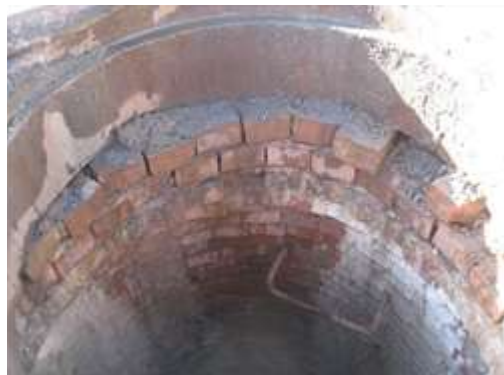
Defect

☒ **Loose Brick**

☒ **Deteriorated**

loose bricks and mortar under chimney

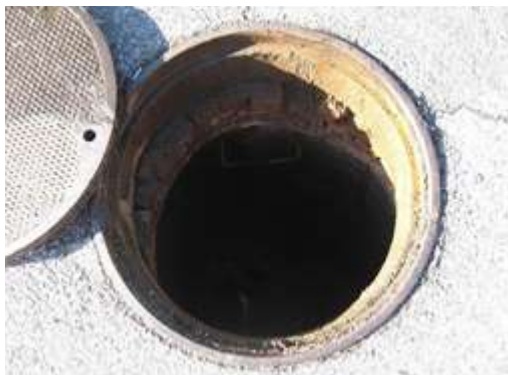
☒ **Leaks**

Frame leaks

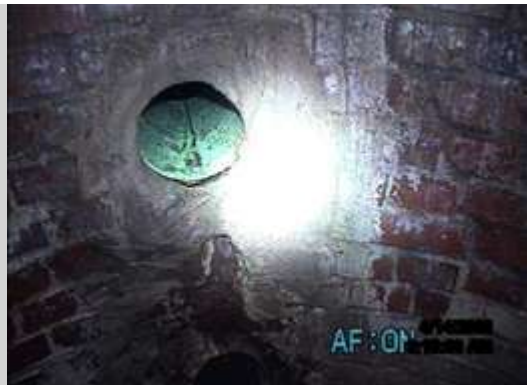
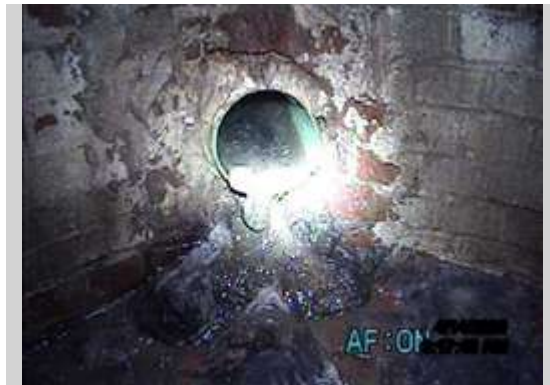
2 O'Clock Inflow

Pipe Height: **7.2** (in.) Rod and Bar (Angled)
Pipe Material: **PVC** ☐ Pipe Lined
Invert Depth: **10.58** (ft.) Flow Characteristics: **Slow**
Deposits: ☐ None ☐ Mud ☒ **Sludge** ☐ Debris ☐ Grease
Silt Depth: **3** (in.) Deposits Extent: **Medium**
Infiltration: **None** Pipe Seal Cond: **Sound**

Drop: **Outside** Rod and Bar
Angled: **Yes** Reading: **11.00** (ft.)
Inv Depth: **12.00** (ft.)
Drop Condition: **Partly Clogged**
